DAVID W TAYLOR NAVAL SHIP RESEARCH AND DEVELOPMENT CE--ETC F/G 13/10  
THE BARBEY REPORT. AN INVESTIGATION INTO CONTROLLABLE PITCH PRO--ETC(U)  
AUG 77 C NOONAN, G ANTONIDES, A ZALOUMIS  
DTNSRDC-77-0080

4. TITLE (and Subtitle) THE BARBEY REPORT. AN INVESTIGATION INTO CONTROLLABLE PITCH PROPELLER FAILURES FROM THE STANDPOINT OF FULL-SCALE UNDERWAY PROPELLER MEASUREMENTS	5. TYPE OF REPORT & PERIOD COVERED Final rpt. Oct 1975 - June 1976	6. PERFORMING ORG. REPORT NUMBER

7. AUTHOR C./Noonan, G./Antonides, A./Zaloumis, B./Corbin R./Schauer	8. CONTRACT OR GRANT NUMBER(s)	
9. PERFORMING ORGANIZATION NAME AND ADDRESS David W. Taylor Naval Ship Research and Development Center Bethesda, Maryland 20084 ✓	10. PROGRAM ELEMENT, PROJECT, TASK AREA & WORK UNIT NUMBERS Task Area SSL 24001 Task 19376 Work Unit 1-1962-133-62

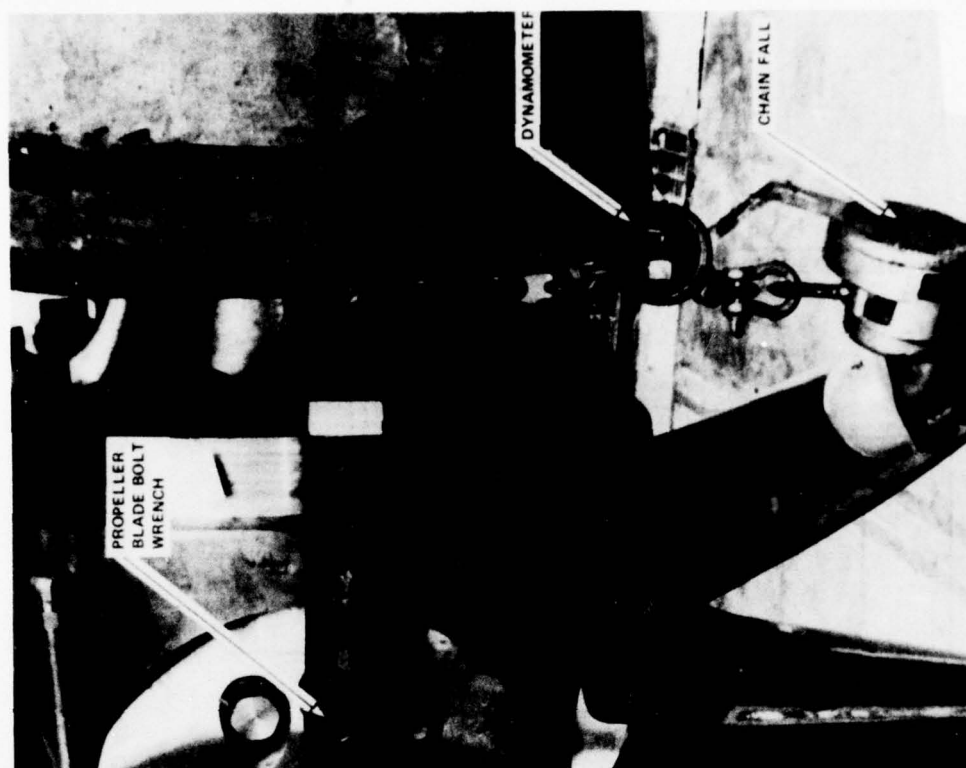
Figure 11 - Improved Bolt Installation  
(Torque/Elongation) Techniques for  
BARBEY

\*\* It was recognized that the original bolt installation technique could also have resulted in insufficient bolt preload. That could have contributed significantly to early bolt fatigue failure.
